HOLMEN AREA FIRE DEPARTMENT EXISTING FIRE STATION CONDITIONS

HOLMEN FIRE DEPARTMENT
710 S Main St, Holmen, WI 54636

HOLMEN AREA FIRE DEPARTMENT
FIELD VERIFICATION

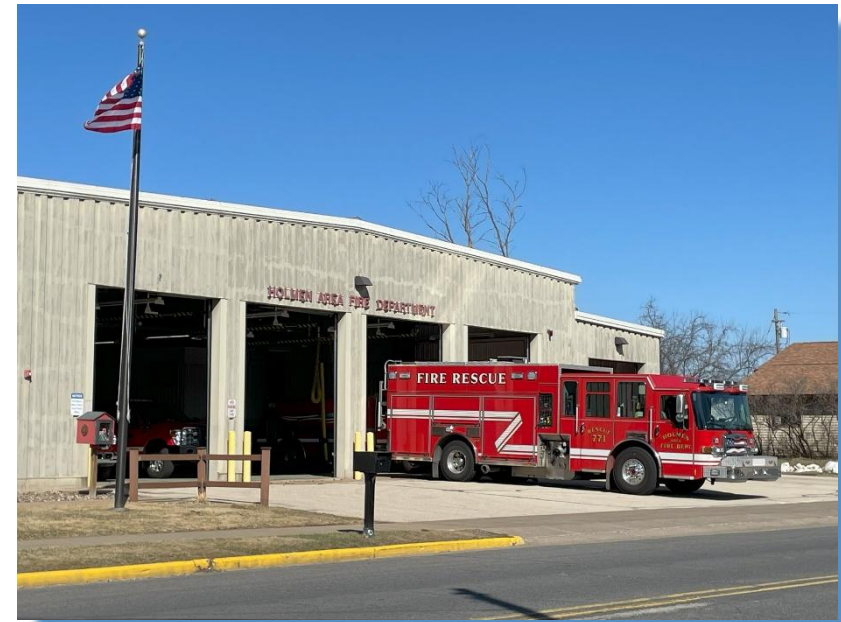
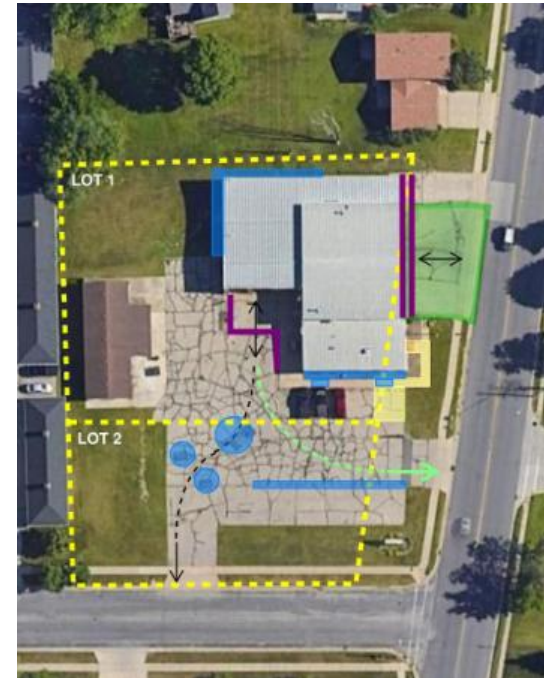
- Back-in bay design and limited visibility create significant collision, injury, and apparatus damage risk
- Front apron configuration forces unsafe operations on Main Street, including traffic stoppage, sidewalk encroachment, and difficult apparatus alignment
- Current Rear-apron response pattern reduces efficiency and increases risk by slowing turnout and routing apparatus through parking areas

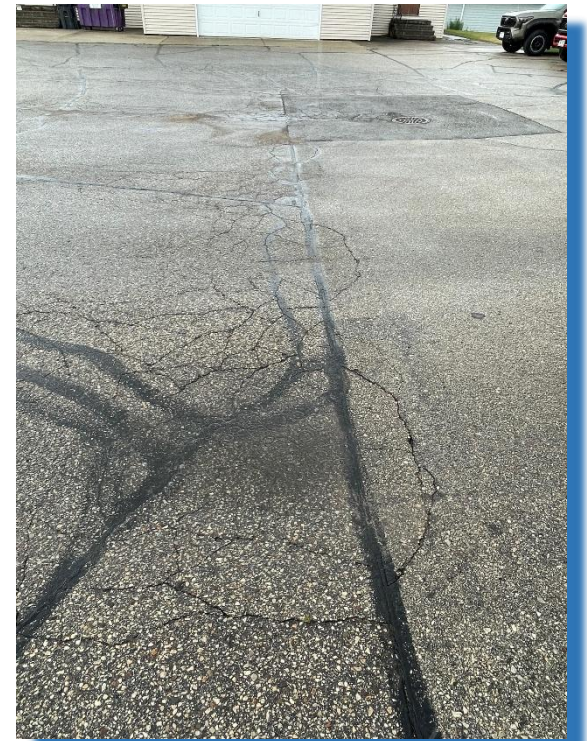
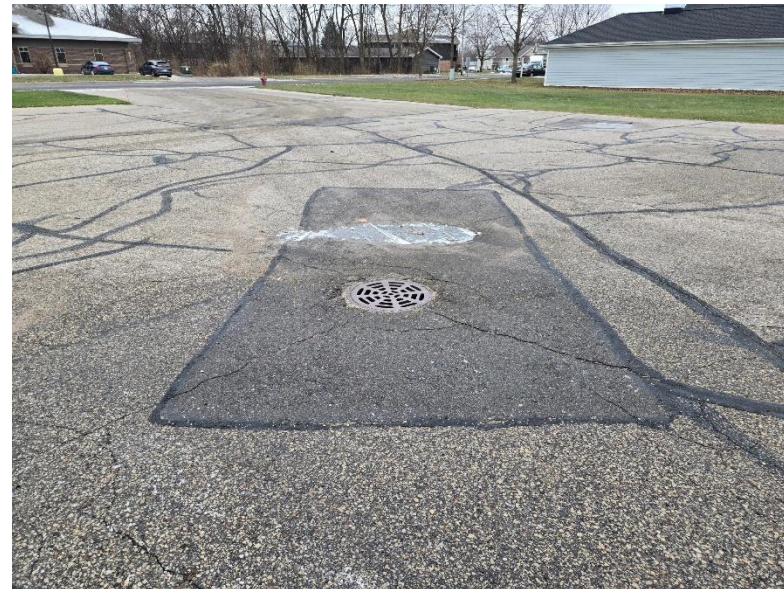
EXISTING CONDITIONS PARKING LOT

- Parking lot has failed pavement and safety hazards with widespread cracking, settlement, uneven surfaces, and ADA non-compliance
- Drainage deficiencies create standing water issues, including pooling near stormwater connections
- Lack of striping and signage creates operational and accessibility concerns, with no defined parking, ADA stalls, or traffic guidance for emergency vehicles

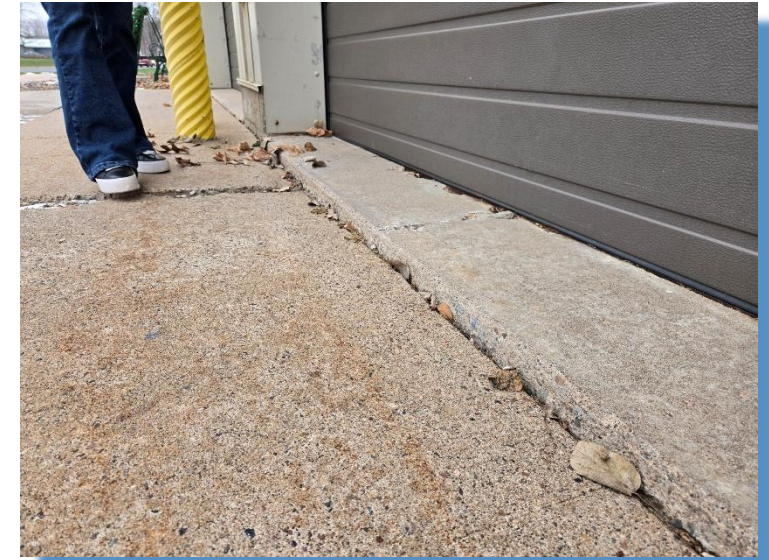
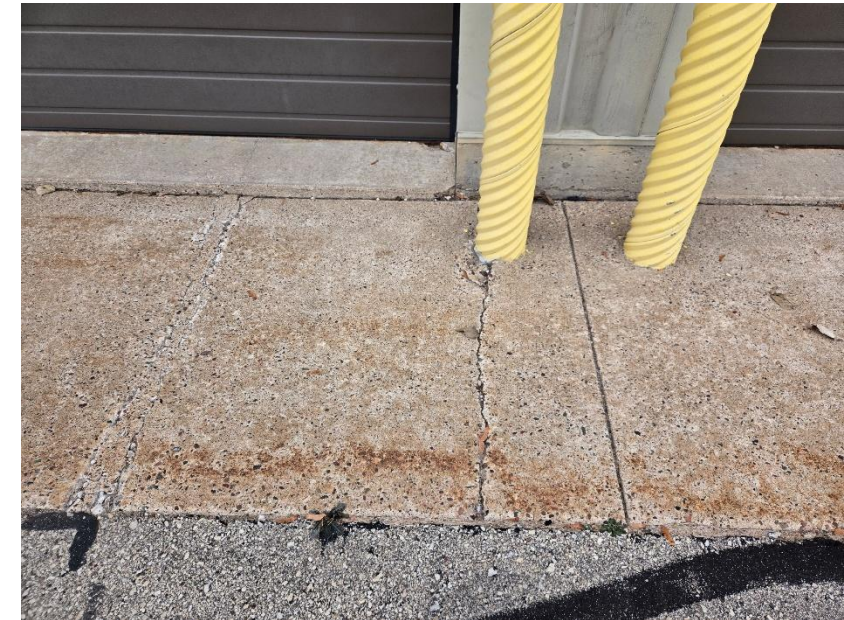
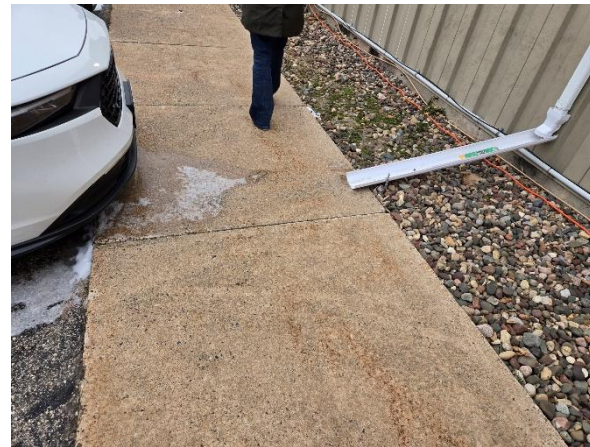
EXISTING CONDITIONS SIDEWALKS

- Uneven, deteriorated pavement and sidewalks with cracking and settlement creating trip/fall hazards
- Surfaces do not meet ADA accessibility requirements, including lack of compliant routes and parking
- Standing water across paved areas and sidewalks increases slip risk and potential ice hazards
- Inadequate pedestrian pathways force foot traffic into apparatus apron areas, creating conflict with emergency vehicles
- Lack of traffic control markings increases risk of vehicle and pedestrian conflicts
- Insufficient curb/tire stop protection allows vehicles to encroach onto pedestrian areas, increasing injury risk

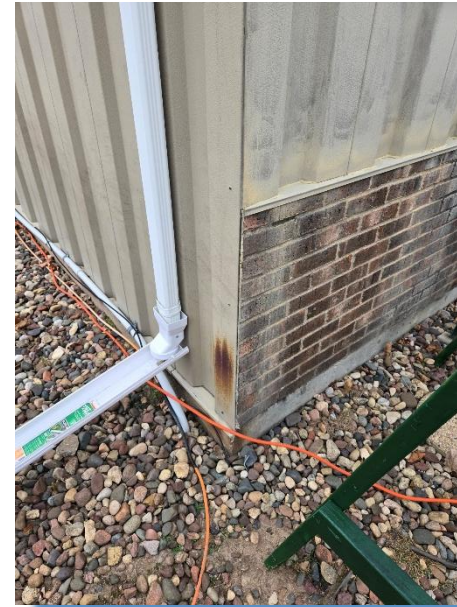
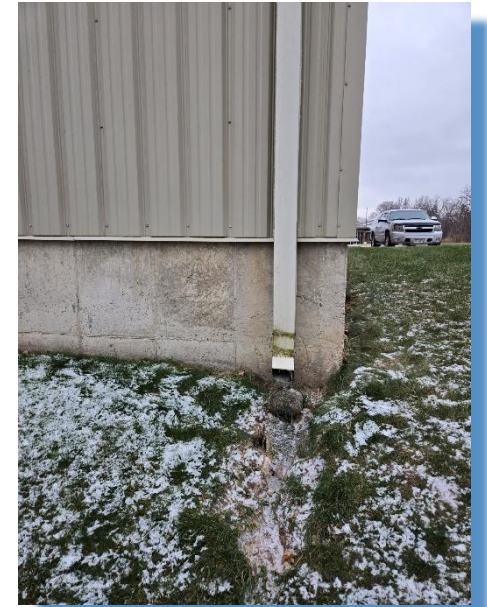
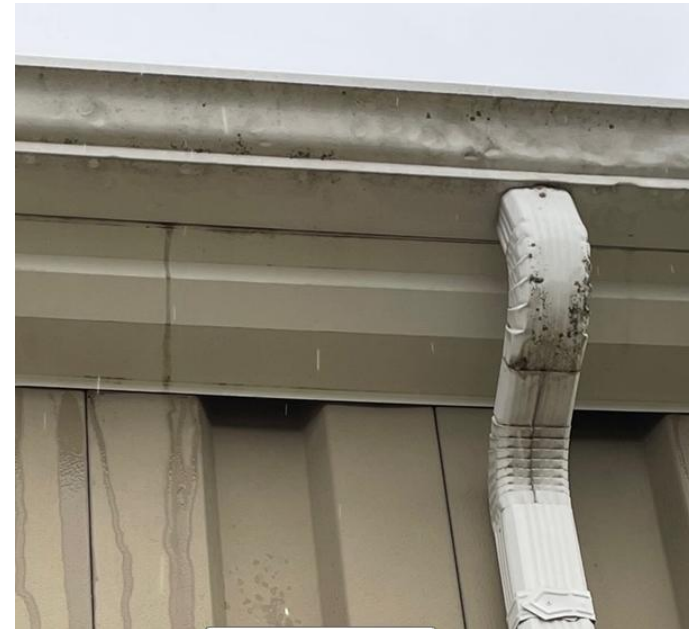
EXISTING CONDITIONS EXTERIOR ENVELOPE

- Aging exterior envelope and low-slope roof are contributing to ongoing water intrusion, requiring continued maintenance and repairs
- Undersized gutters and poor drainage are accelerating building deterioration, causing overflow, fascia damage, and infiltration
- Improper downspout discharge creates site and safety issues, including foundation pooling, erosion, and ice hazards on adjacent walkways

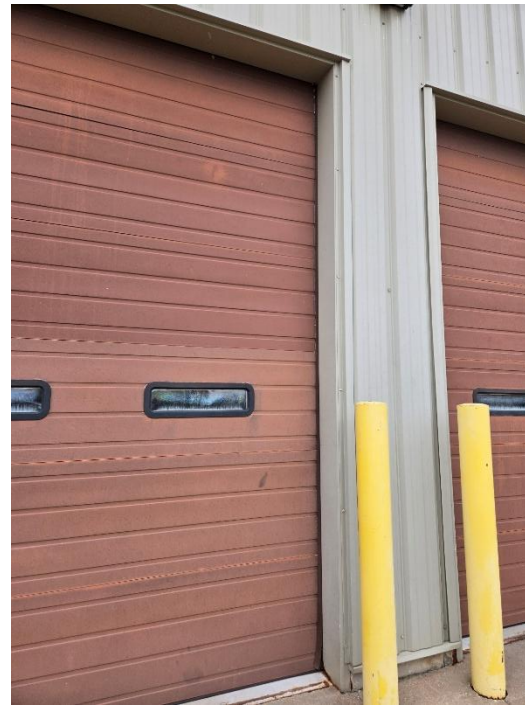
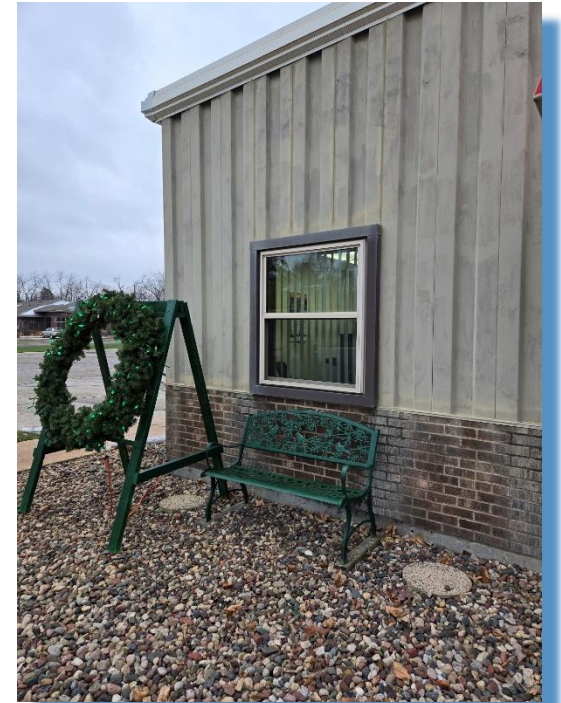
- Doors, windows, and overhead apparatus doors are aging and nearing or beyond end of life, with deterioration and leakage concerns
- Openings do not meet current standards, including ADA accessibility and likely energy code requirements, contributing to performance and compliance issues

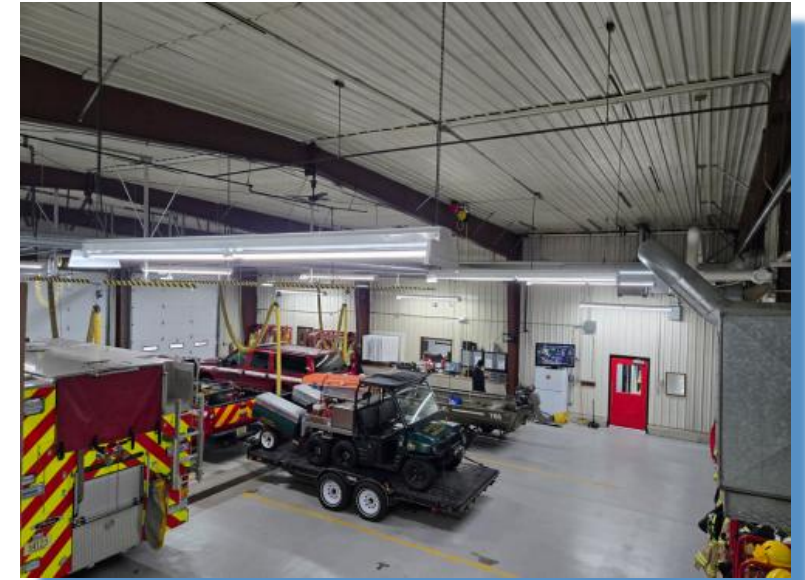
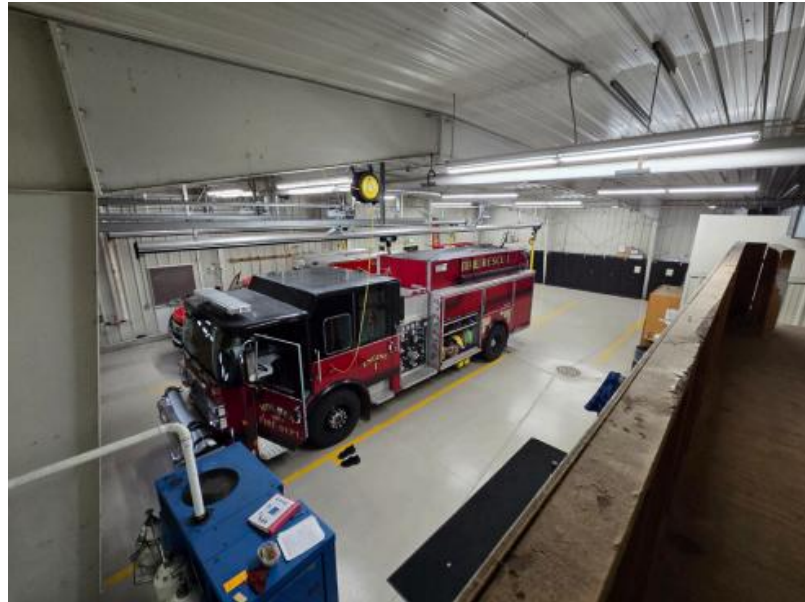
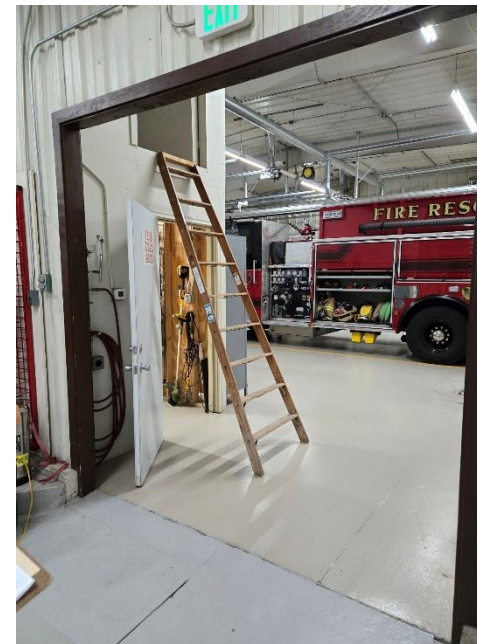
APPARATUS BAYS

- Inefficient bay layout increases response delays and risk, with rear first-out apparatus, indirect access, and poor radio coverage
- Bays do not meet modern apparatus standards, lacking drive-through design with inadequate clearances, depth, and height
- Interior conditions create safety hazards, including poor lighting, overhead obstructions, deteriorated floors, drainage issues, and outdated doors.

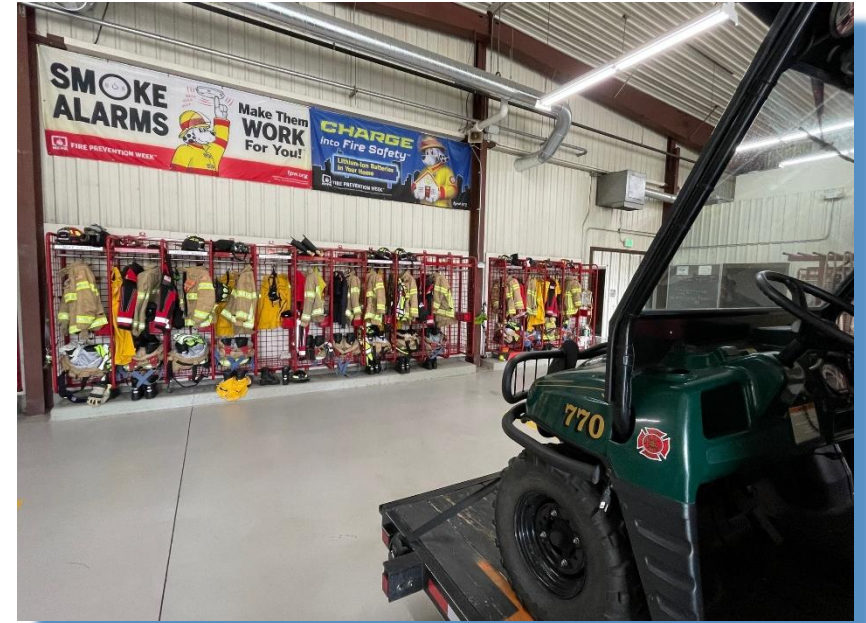
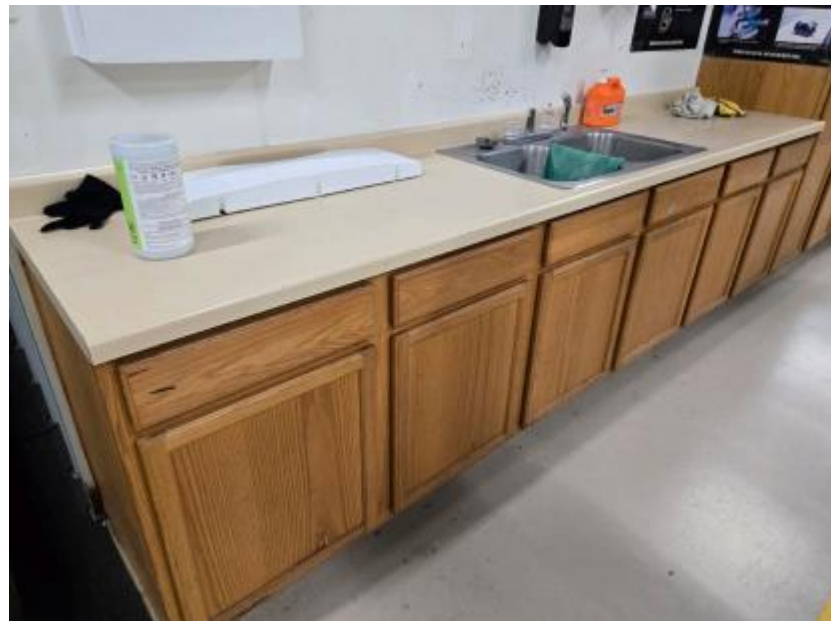
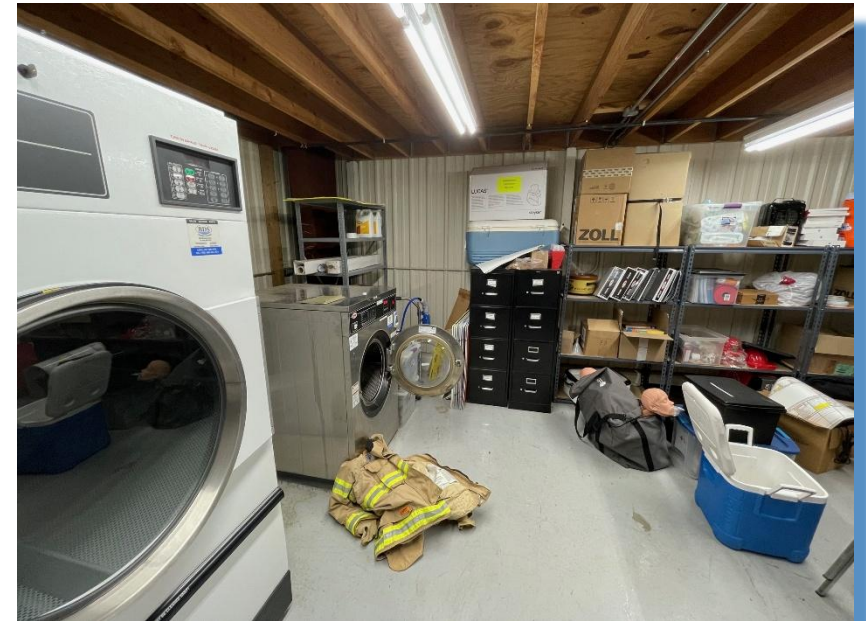
PPE STORAGE, DECON AREA

- PPE storage located in apparatus bay exposes gear to carcinogens and contaminants
- PPE placement increases response inefficiencies and congestion in travel paths
- Lack of dedicated PPE storage and turnout space limits effective decontamination practices
- Decontamination areas are undersized, inefficient, and fragmented throughout the bay
- Decon sink is inadequate for proper equipment cleaning

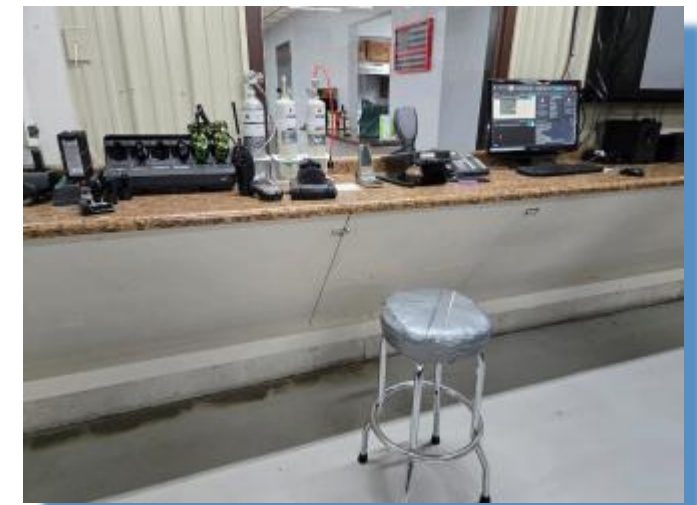
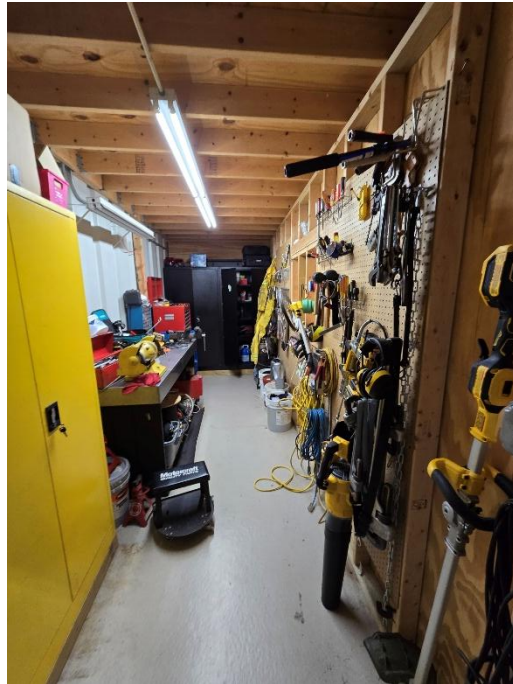
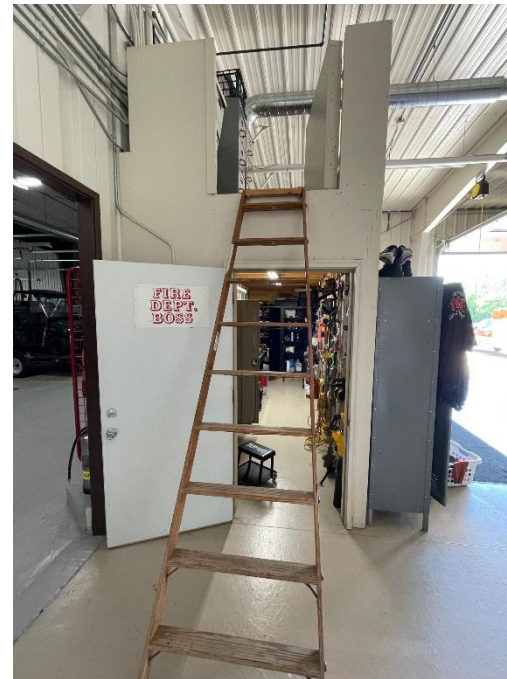
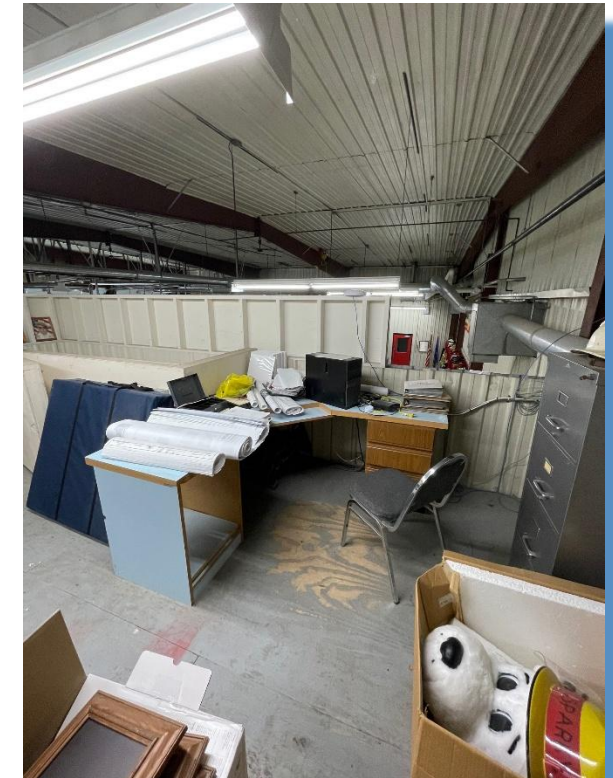
WATCH AREA, WORKSPACE, STORAGE

- Station layout and mechanical systems do not support proper hot/warm/cold zone separation
- Watch room located in apparatus bay exposes staff and equipment to contaminants
- Limited office space forces work activities into the hot zone
- Limited storage space forces unsafe, non-compliant storage solutions
- Workshop is undersized, unventilated, and located in the apparatus bay

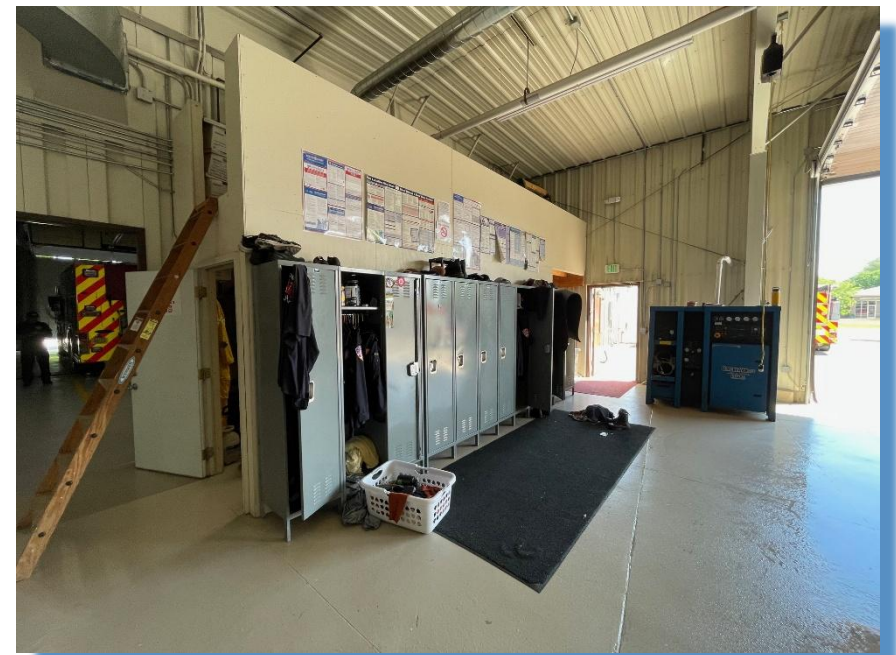
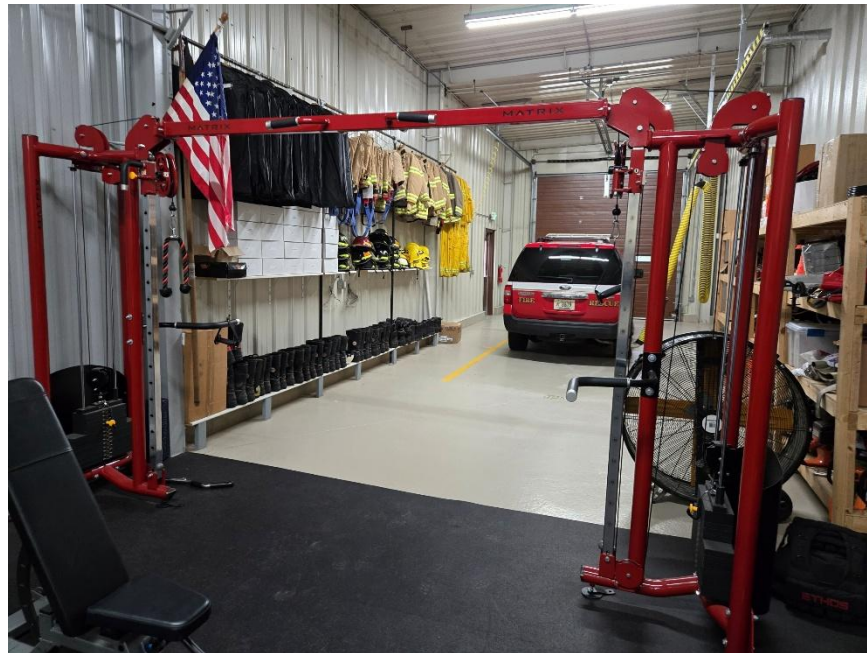
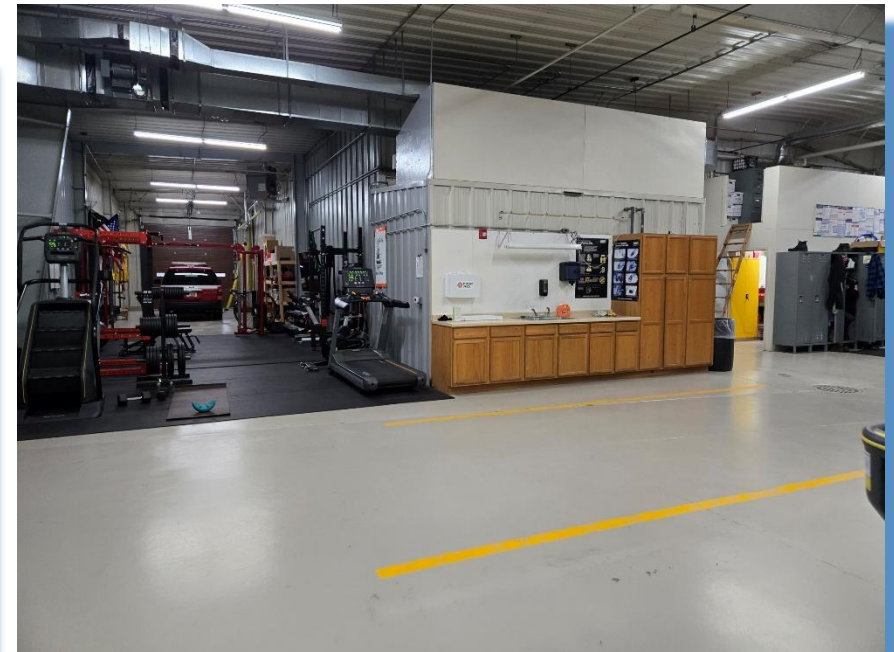
EXERCISE, LOCKERS, DECON

- Personal lockers in apparatus bay increase carcinogen and cross-contamination exposure
- Exercise room located in apparatus bay exposes personnel to carcinogens and temperature extremes

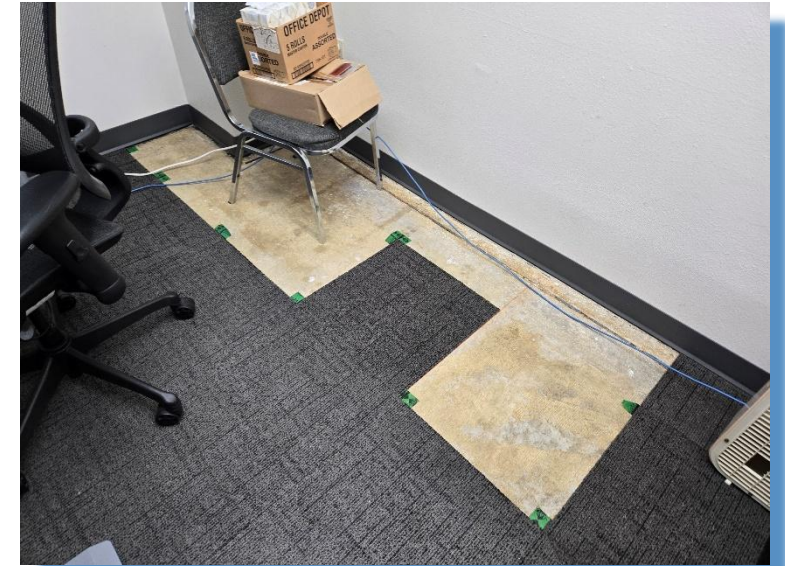
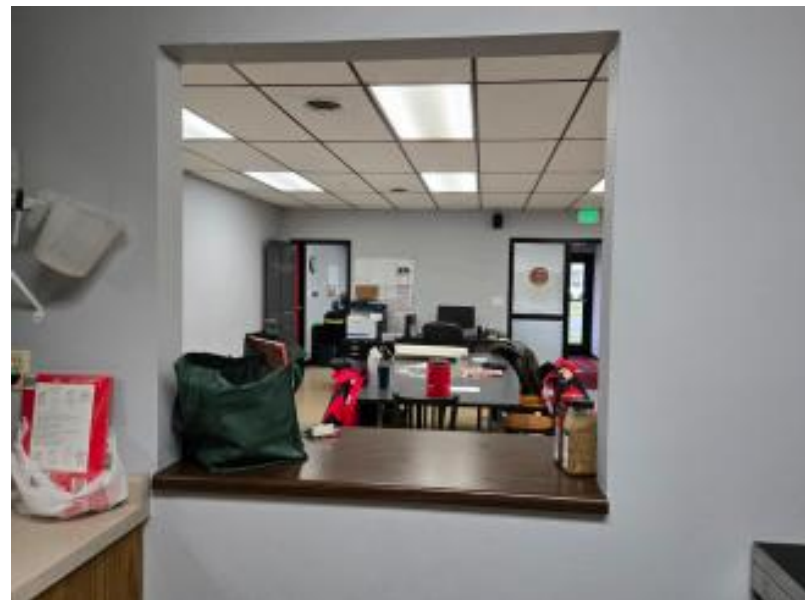
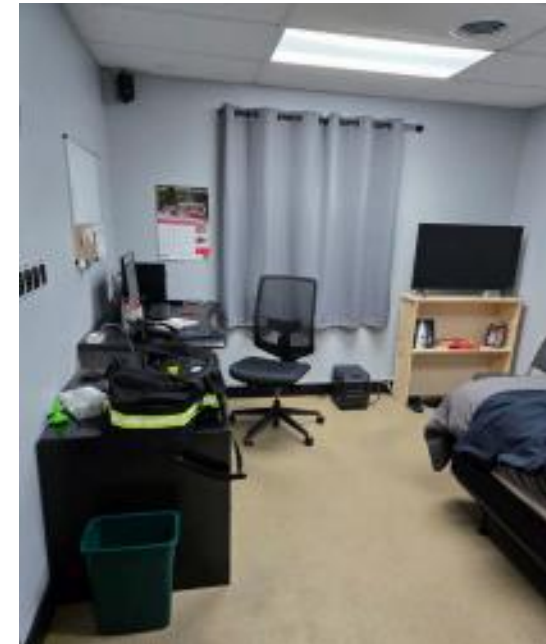
EXISTING CONDITIONS OFFICE, KITCHEN, DAY ROOM

- Chief's office placement forces front doors to remain locked
- Ongoing water intrusion damaging walls, ceilings, and flooring throughout
- Structural settlement causing slab cracking
- Company Officer dorm/office space does not meet IBC requirements
- Direct bay access exposes occupants to carcinogens
- Multipurpose room undersized and overused
- Kitchen undersized, deteriorated, and not ADA compliant

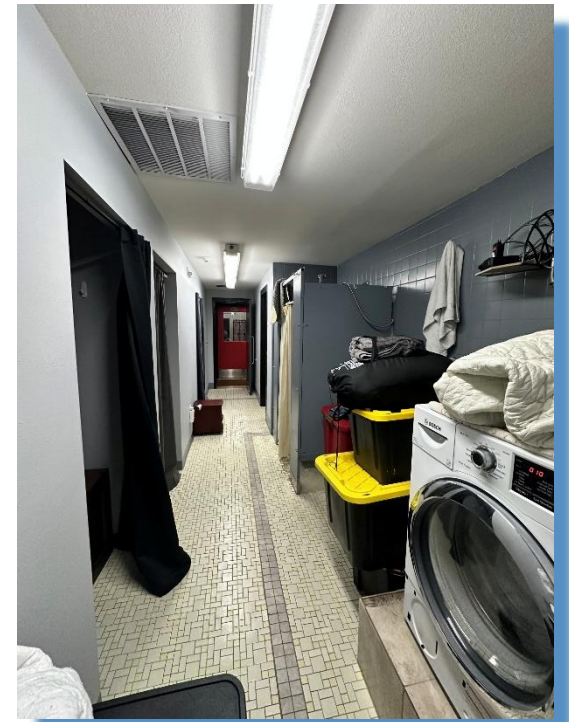
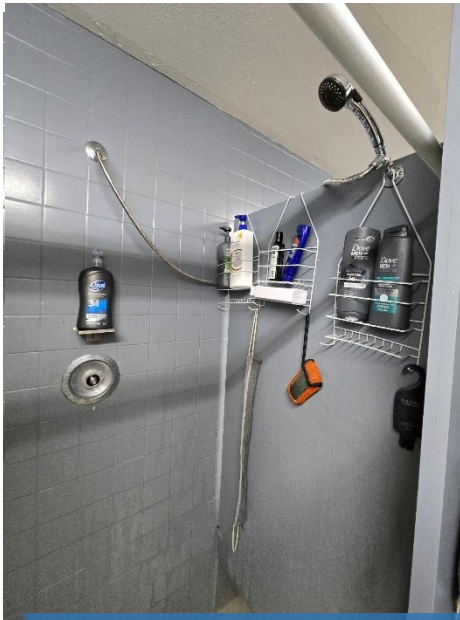
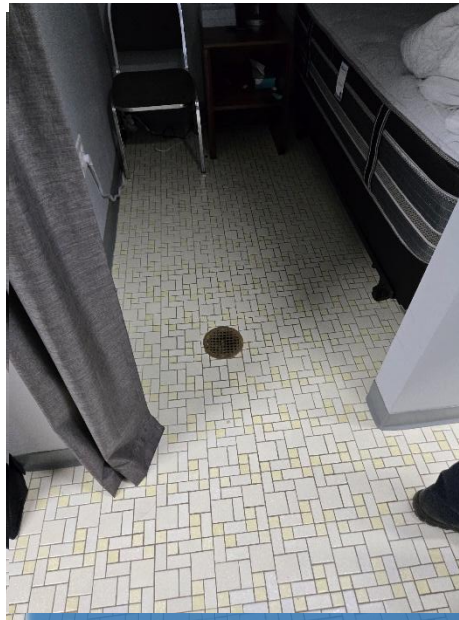
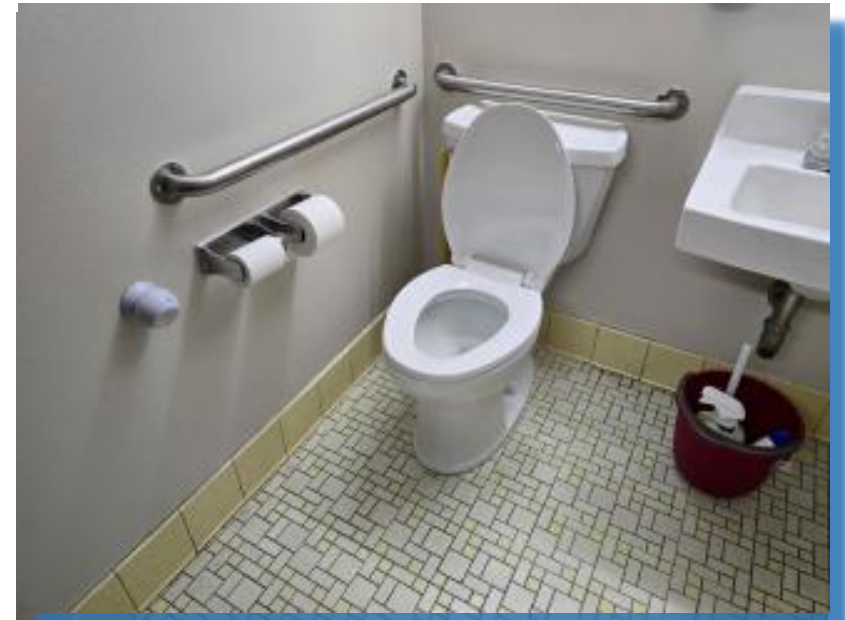
EXISTING CONDITIONS SLEEPING DORM AREA

- Dorms poorly constructed with inadequate privacy
- Persistent odors from floor drains
- No windows in dorms
- Extreme temperature swings in dorms
- Dorm and living areas not ADA or code compliant
- Poor overall indoor air quality with reported respiratory issues
- Spaces inadequate for a mixed gender career fire department
