HOLMEN AREA FIRE DEPARTMENT EXISTING FIRE STATION CONDITIONS

HOLMEN FIRE DEPARTMENT
710 S Main St, Holmen, WI 54636

HOLMEN AREA FIRE DEPARTMENT
FIELD VERIFICATION

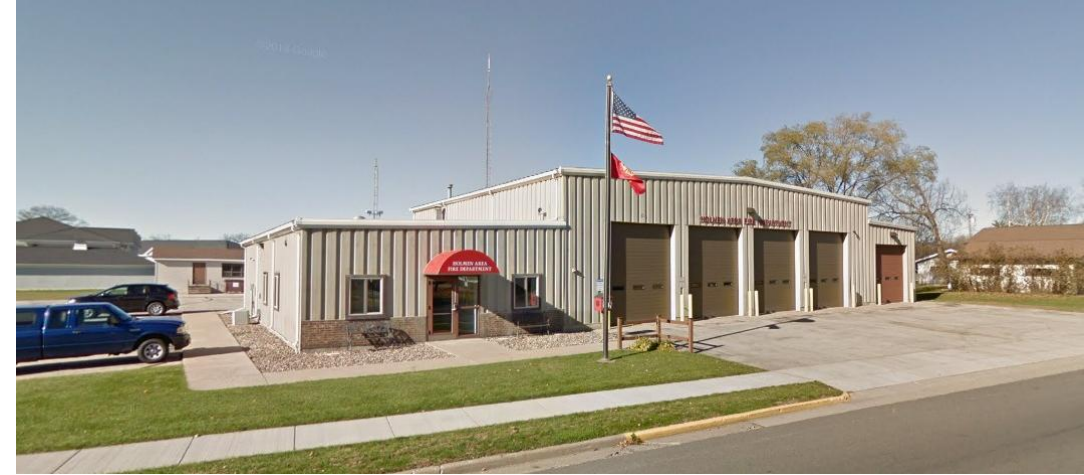
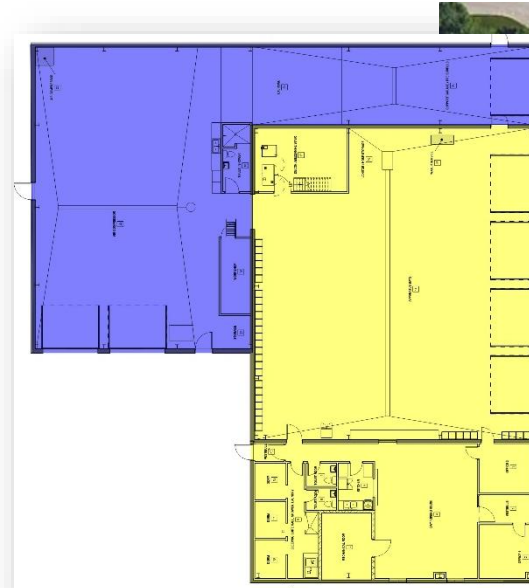
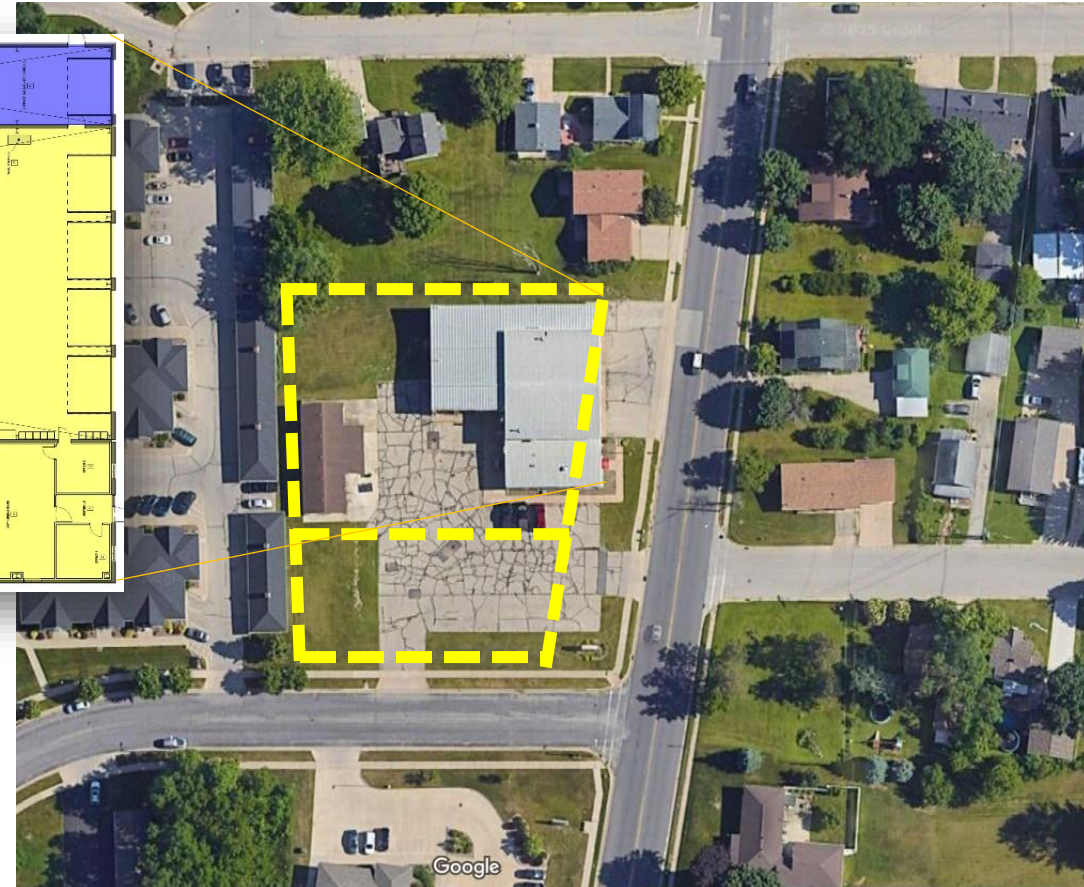
- Back-in bay design and limited visibility create significant collision, injury, and apparatus damage risk
- Front apron configuration forces unsafe operations on Main Street, including traffic stoppage, sidewalk encroachment, and difficult apparatus alignment
- Current Rear-apron response pattern reduces efficiency and increases risk by slowing turnout and routing apparatus through parking areas

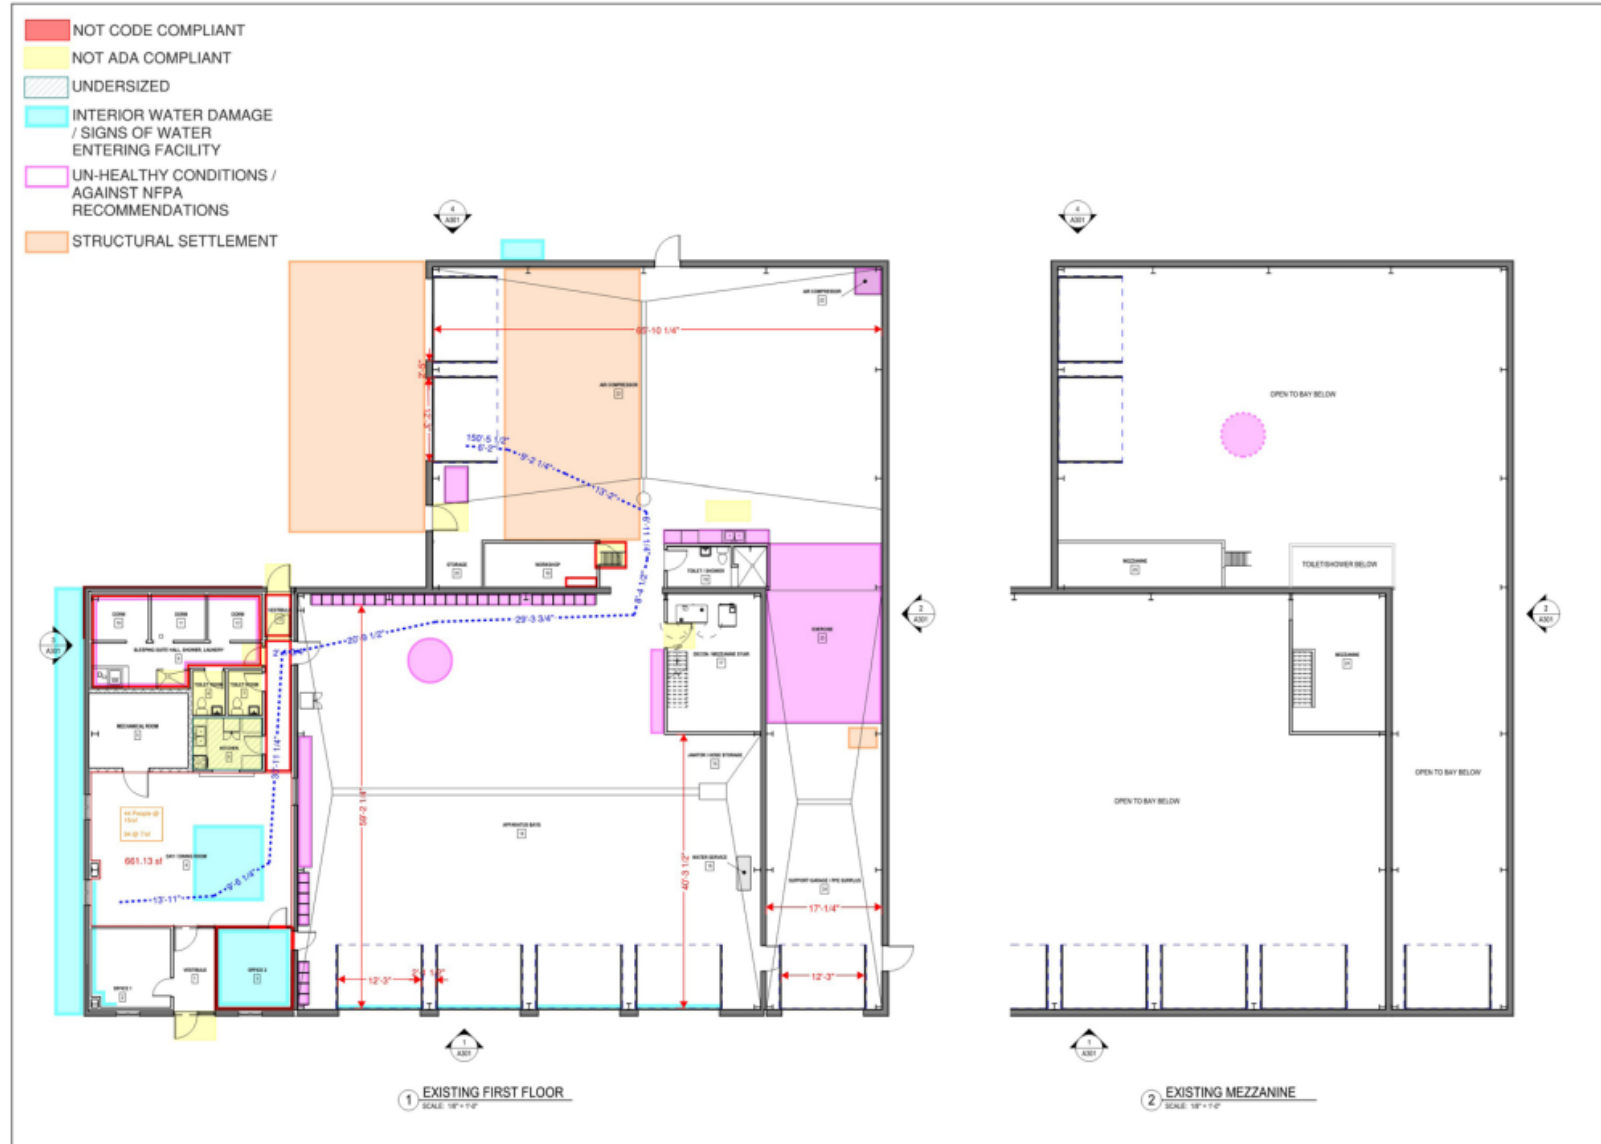
EXISTING FLOOR PLAN

- NOT CODE COMPLIANT
- NOT ADA COMPLIANT
- UNDERSIZED
- INTERIOR WATER DAMAGE / SIGNS OF WATER ENTERING FACILITY
- UN-HEALTHY CONDITIONS / AGAINST NFPA RECOMMENDATIONS
- STRUCTURAL SETTLEMENT

- Facility has exceeded its expected life cycle and requires major maintenance and structural upgrades
- Building does not meet current IBC or ADA requirements
- Renovations would require bringing all non-compliant elements up to code
- Does not meet NFPA guidelines for modern fire stations
- Does not meet functional or space needs of a contemporary career department
